# **Argonne Thermal Source Reactor D&D Project**

The Argonne Thermal Source Reactor (ATSR) facility was located in Bldg. 316. The light-water moderated reactor was fueled with highly enriched (93.5%) Uranium-235 and was capable of operating at 10 kW for sustained periods. D&D work was contracted to MOTA Corporation (Columbia SC) in July 1998, and D&D activities began July 29.

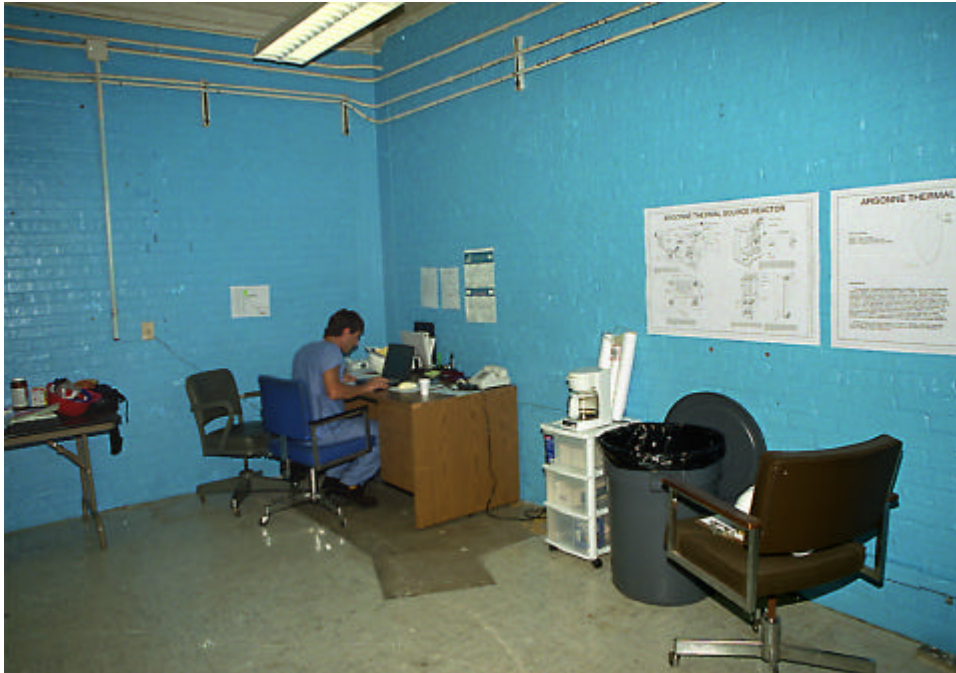
During facility characterization, loose flaking lead-based paint was identified in the ATSR control room. Peel Away™ paint remover was applied to the walls, and the paint was stripped away. Paint residue was collected on paper and rags, and packaged as hazardous waste. The walls were repainted with latex paint to prevent any additional flaking, as shown in this photo (ANL Neg. No. 24571K, Frame 6A).

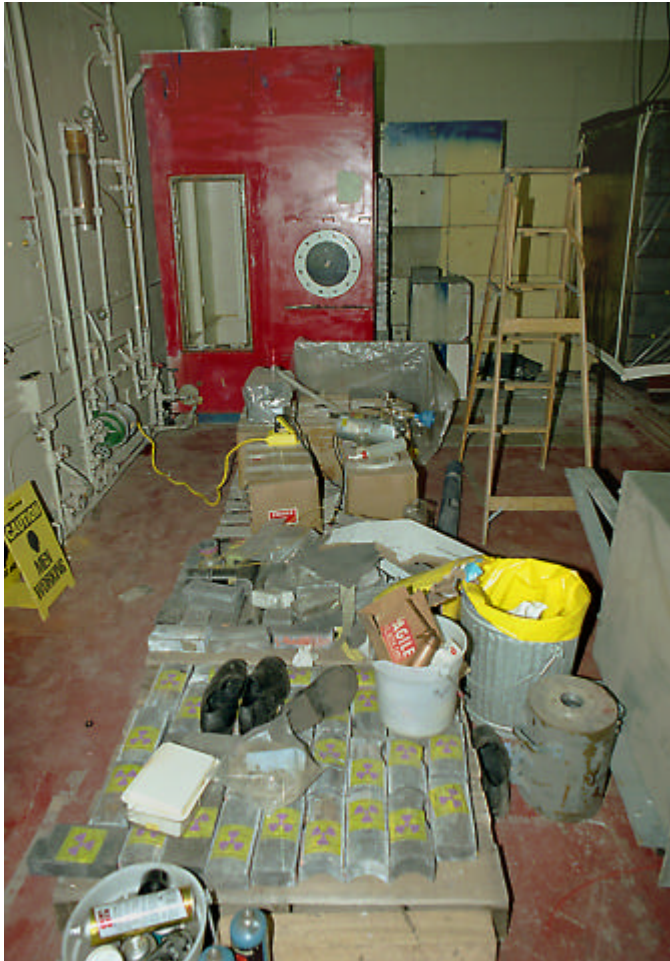
Approximately 20,000 lbs. of activated and contaminated lead were present inside the ATSR facility. The lead was stacked on pallets prior to packaging into B-12 metal bins. The material was transferred to ANL Waste Management Operations for storage as mixed waste (ANL Neg. No. 24571K, Frame 15A).

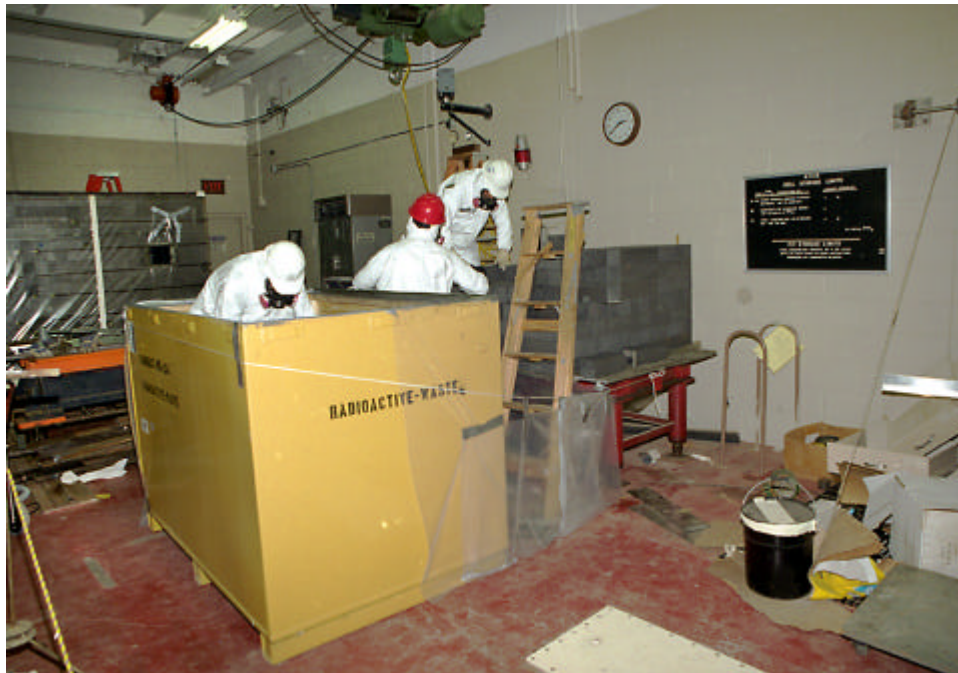
Two piles of graphite were found in the facility, the ATSR graphite pile and graphite from the original Chicago Pile-1 (CP-1) reactor that was being stored at ATSR. These piles were unstacked and packaged into waste containers for disposal as low-level radioactive waste. This photo shows D&D technicians packaging graphite from CP-1 (ANL Neg. No. 24572K, Frame 26A).

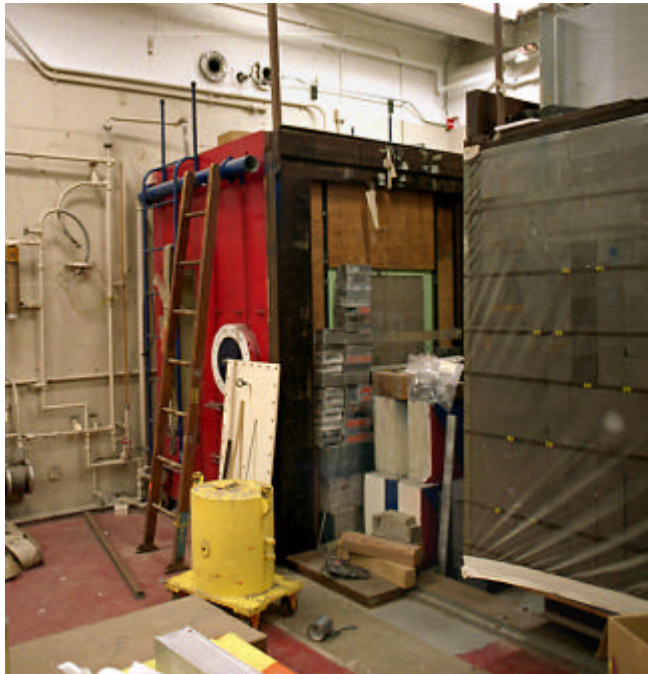
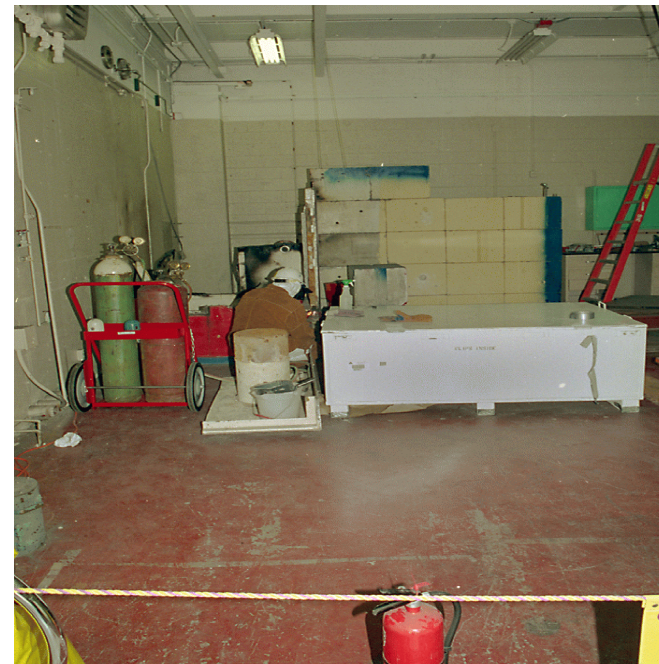
These photos show the Argonne Thermal Source Reactor prior to and during removal operations. Surrounding the ATSR core tank were 6 inches on lead shielding. After removing the shield tank covers, the lead block shielding was removed from around the core tank and packaged as mixed waste. Removal of the reactor and shield tank involved the disassembly, size reduction, and packaging as low-level radioactive waste, the reactor internals, core tank, and shield tank (ANL Neg Nos. 23988K, Frame 1, and 24637K, Frame 19A).

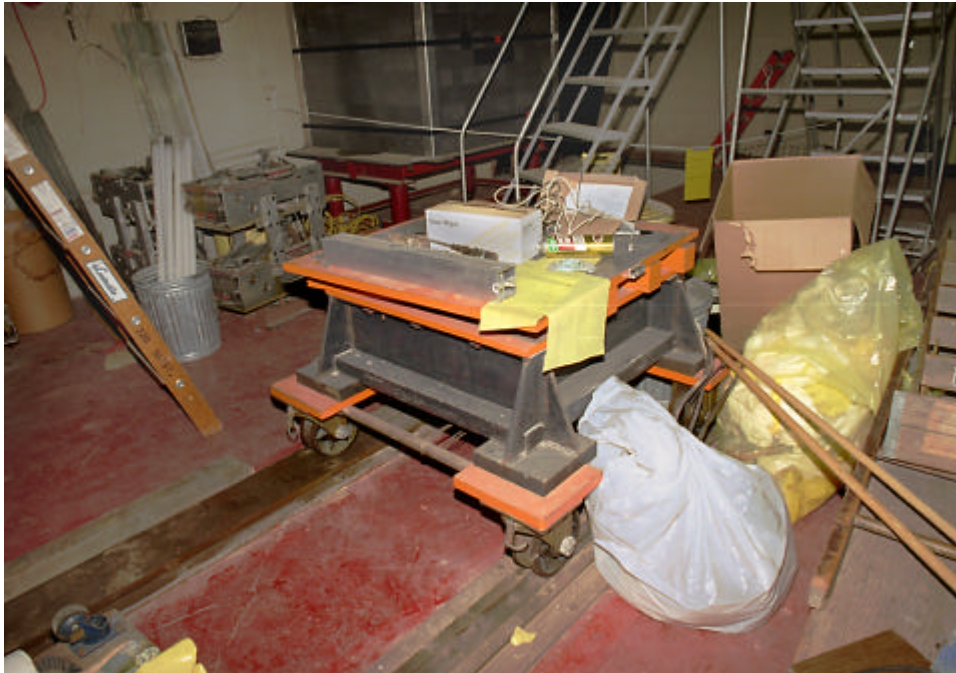
A Snell block was used to obtain fast-reactor-like fluxes of neutrons for research purposes. The block was installed on rail-mounted tables and could be positioned next to the leakage face of the reactor. This photo shows a Snell block table that was located in the ATSR facility. It was dismantled, size reduced, and packaged for disposal as low-level radioactive waste (ANL Neg. No. 23988K, Frame 29).

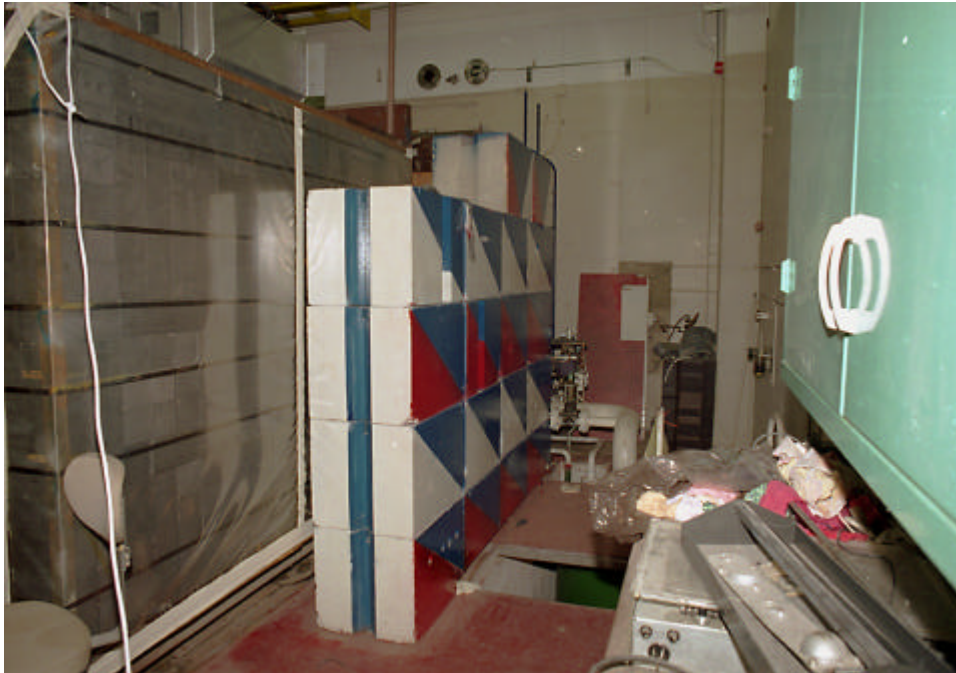
Twenty activated concrete shield blocks were removed and packaged as low-level radioactive waste. ANL safety procedures required a lift plan and special rigging due to the absence of the facility's original lifting and rigging equipment (ANL Neg. No. 23988K, Frame 33).

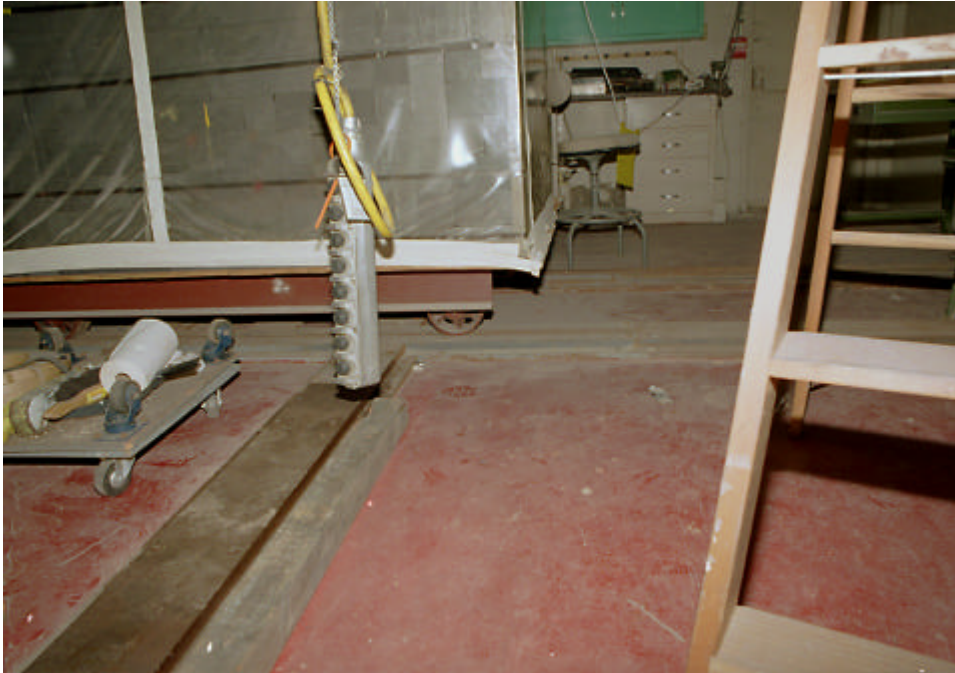
Steel floor tracks for the ATSR and the rail-mounted Snell block tables were removed, size reduced, and packaged as low-level radioactive waste (ANL Neg. No. 23988K, Frame 30).

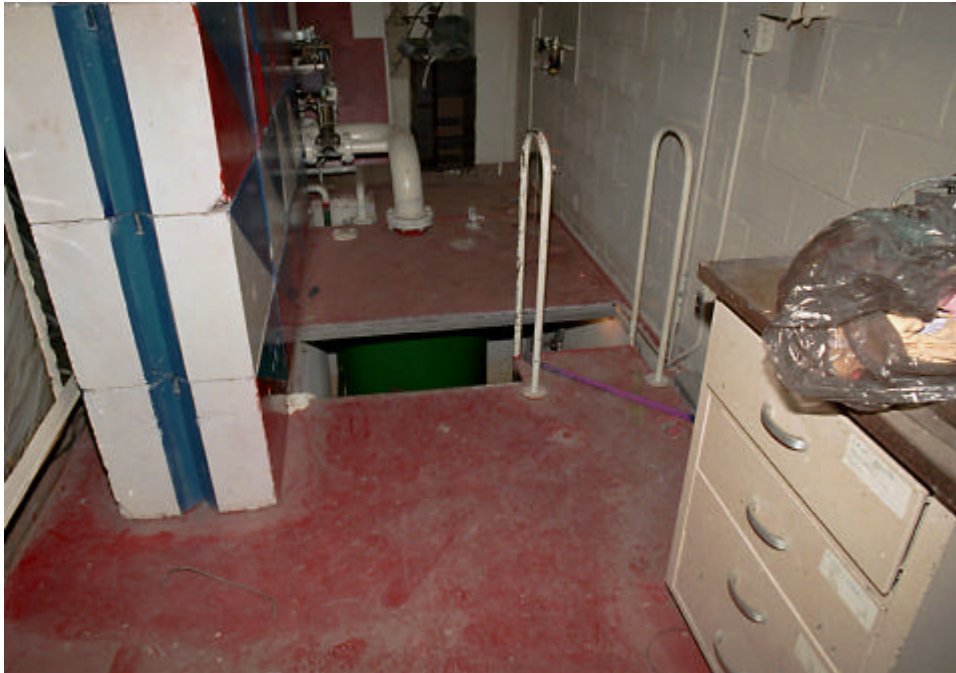
The reactor dump tank, located in a floor pit just north of the reactor, was rigged and lifted from the floor pit, size reduced, and packaged as low-level radioactive waste (ANL Neg. No. 23988K, Frame 12).

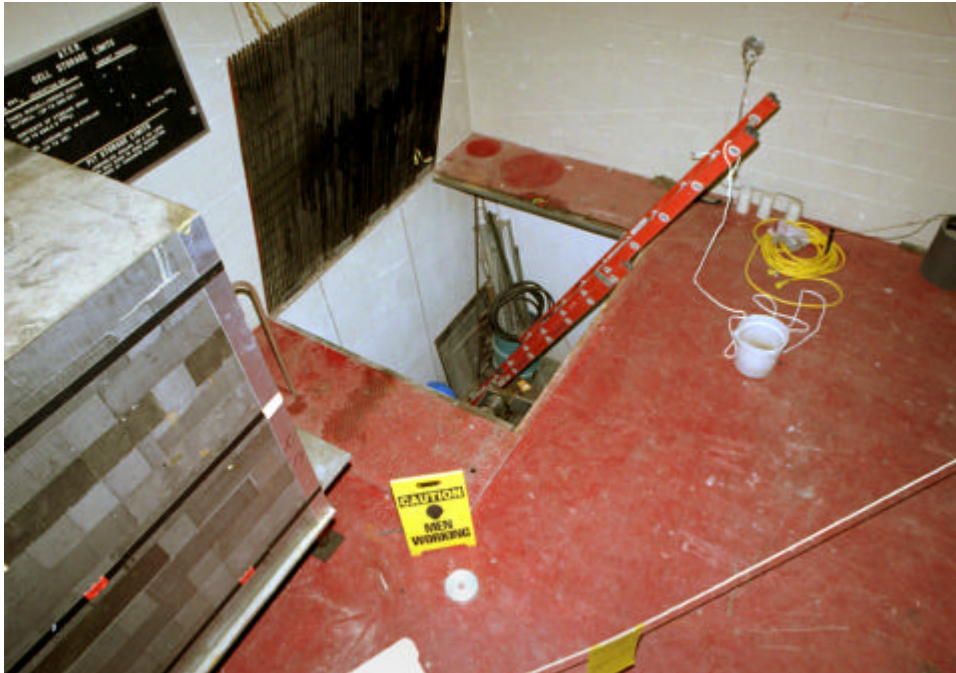
The fuel storage pit contained a large quantity of miscellaneous equipment and material. The pit was emptied and the material packaged as low-level radioactive waste (ANL Neg. No. 23988K, Frame 26).

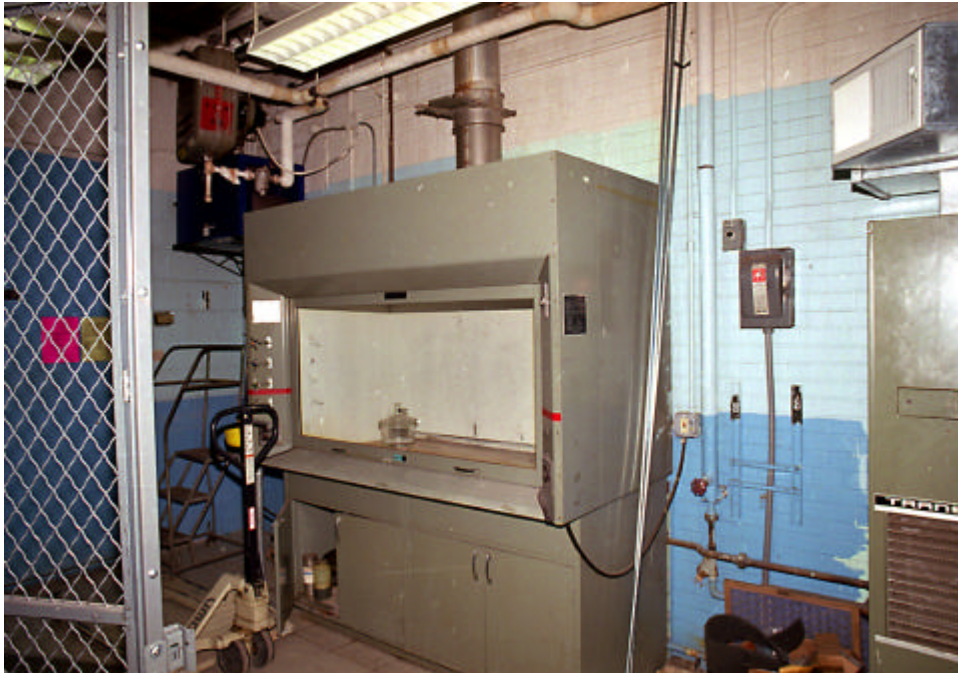
The fume hood was disconnected from existing services (air, electrical, HEPA ventilation), relocated to a contamination control area, and size reduced and packaged as low-level radioactive waste (ANL Neg. No. 23988K, Frame 5).

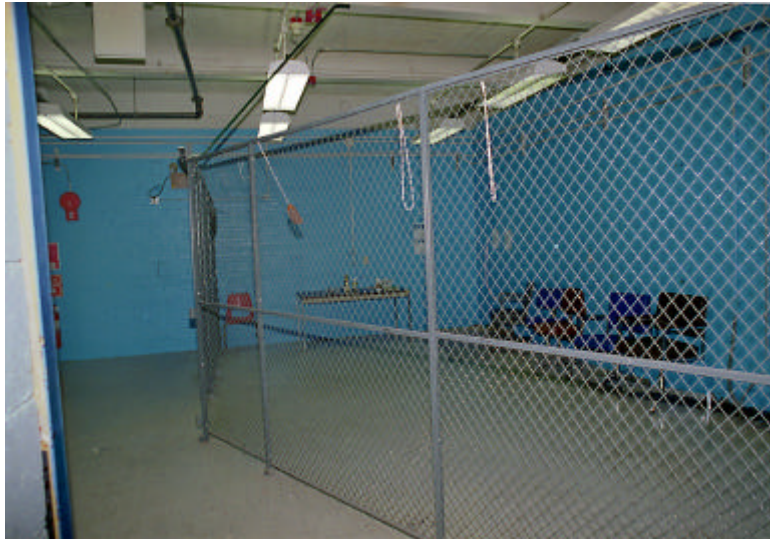
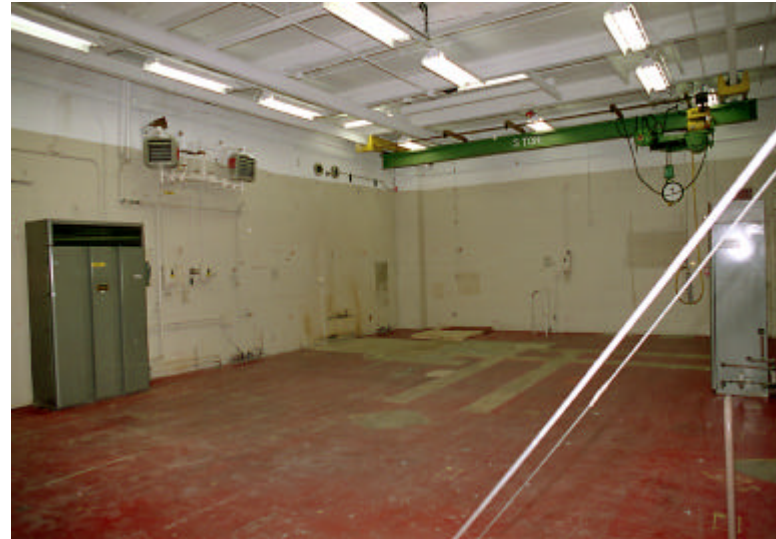
D&D activities were completed in September. The following photos show the post-D&D condition of the ATSR facility control room and the reactor room area looking northeast (ANL Neg. Nos. 24748K, Frame 9, and 24748K, Frame 10).

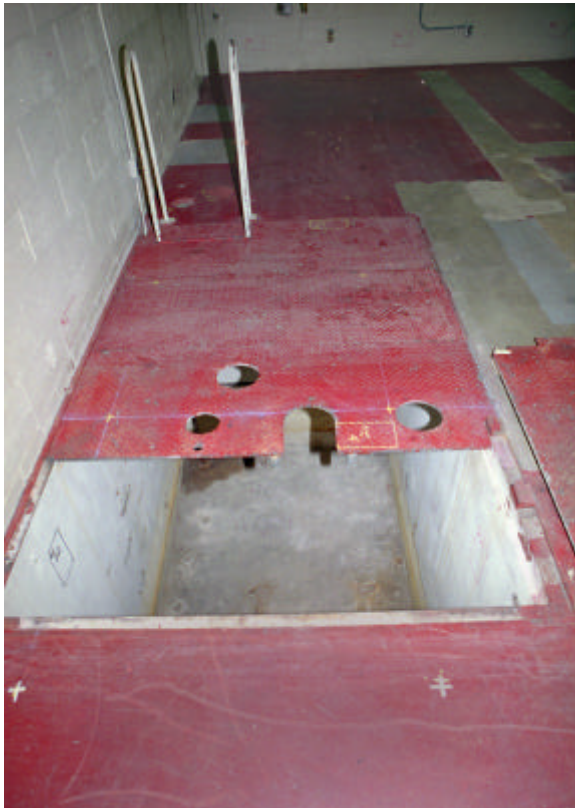
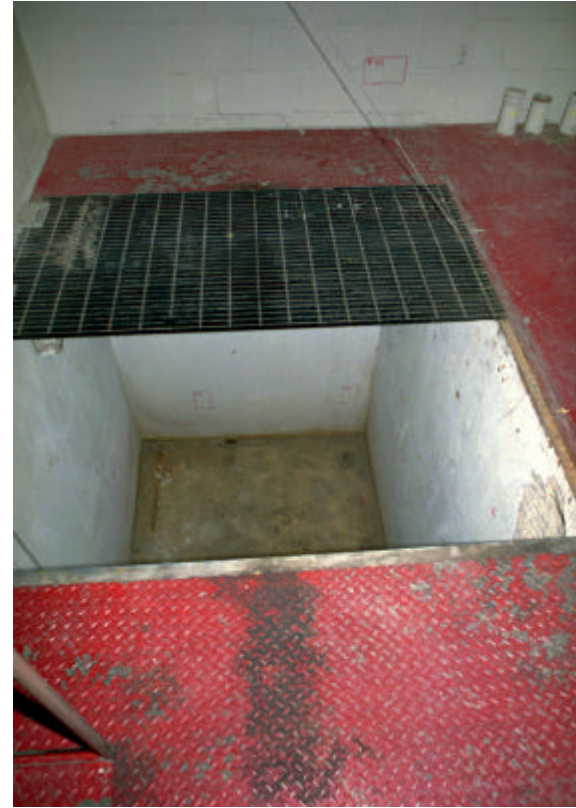
These photos show the post-D&D condition of the ATSR dump tank pit and the fuel storage pit (ANL Neg. Nos. 24748K, Frame 15, and 24748K, Frame 16).
